**[Docket No. 2003-SW-26-AD; Amendment 39-13198; AD 2003-12-13]**

#### **Airworthiness Directives; Agusta S.p.A. Model A109K2 Helicopters**

**2003-12-13 Agusta S.p.A.:** Amendment 39-13198. Docket No. 2003-SW-26-AD.

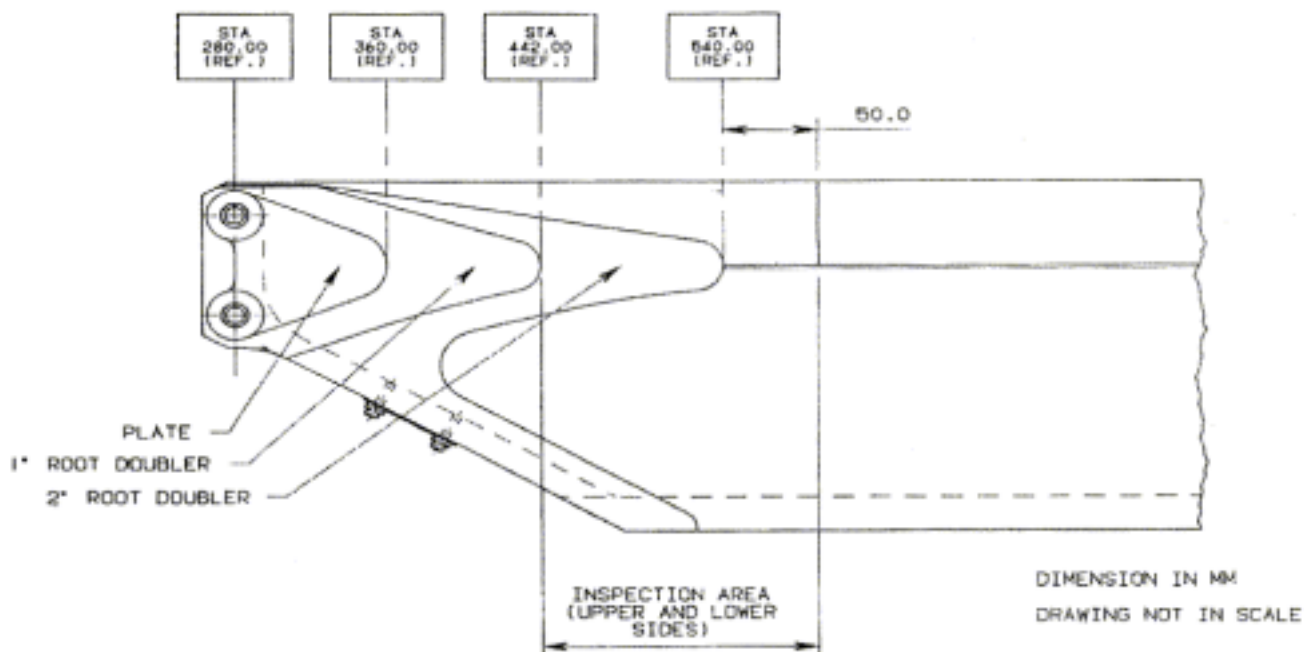
**FIGURE 1**

(a) Before each start of the helicopter engines, visually check the upper and lower surfaces of each blade for a crack in the area depicted in Figure 1 of this AD. An owner/operator (pilot) holding at least a private pilot certificate may perform this check, but must enter compliance with this paragraph into the aircraft records in accordance with 14 CFR sections 43.11 and 91.417(a)(2)(v). See Figure 1:

**Note 1:** Paint irregularities on the blade may be due to a crack.

(b) Before the first flight of each day, and thereafter at intervals not to exceed 5 hours TIS, and anytime an increase in vibration levels occurs, inspect each blade for a crack using a 5x or higher magnifying glass in accordance with Part II of the Compliance Instructions of Alert Bollettino Tecnico No. 109K-35, dated May 13, 2003 (ABT) and Figure 1 of this AD.

(c) After each visual inspection using a 5x or higher magnifying glass and before further flight, if you are unable to determine by the visual inspection whether there is a crack, inspect each blade for a crack using a dye-penetrant method in accordance with Part II of the Compliance Instructions of the ABT and Figure 1 of this AD.

(d) If a crack is found, replace each cracked blade with an airworthy blade before further flight.
